Manhole Inspection Summary

Manhole # S03YY1023MH

Insp Date: **8/14/06 12:00 AM**

Location Address: **3301 LUDGATE RD**

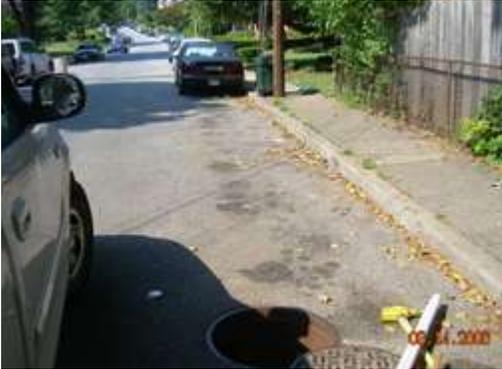
Location View

Frame leaks. Frame offset. Adjustment deterioration, loose brick, and infiltration. Corbel and Barrel infiltration.
